A Reactor Emergency

... with resulting improvements

By G. W. Hatfield

Atomic Energy of Canada Limited
Chalk River, Ontario, Canada

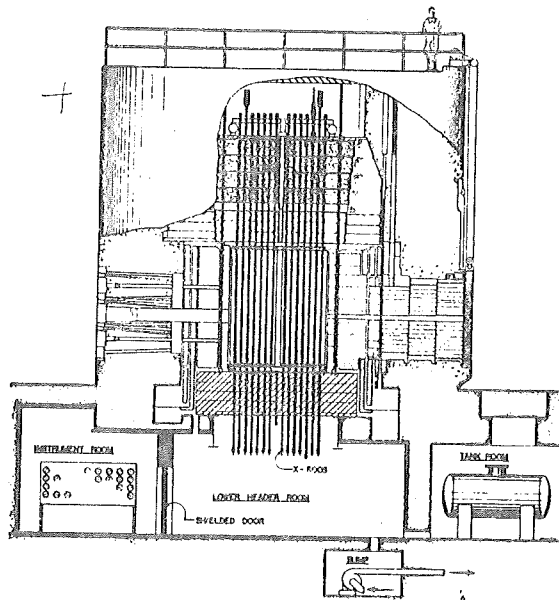
Fig. 1 Cross section of the NRX reactor which had been in operation for five years when a mechanical failure caused a near-disastrous emergency

On December 12, 1952, a low-power experiment was being carried out in Canada's NRX nuclear reactor which had been operating for 5 years. Owing to a complex chain of events, a mechanical failure occurred in the shutoff-rod system which resulted in a power surge. About 10 per cent of the uranium rods in the reactor had temporary connections made to them to permit a reduced flow of cooling water for experimental purposes and the overheating resulting from the power surge caused the reduced flow of water to boil to the extent that some of the uranium and aluminum melted. Breaks occurred in some of the calandria tubes as well as uranium sheaths and water tubes on the uranium rods, thereby permitting cooling water to flow into the basement beneath the pile. Thus some uranium metal became exposed to the cooling water and fission products were leached out into the water flooding the basement.

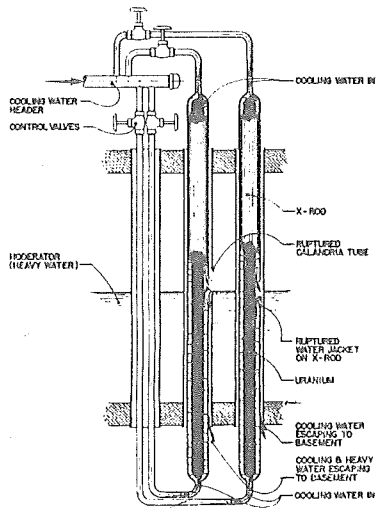
Fig. 3 indicates the problem which faced the staff and represents two different examples of ruptured rods where cooling water in contact with bare uranium was flooded into the basement. It was not considered safe to shut off this flow of cooling water as the condition of the uranium was not known. The main concern was the

fact that some of this uranium was highly irradiated and, if this uranium were not cooled, it would heat up to the point where the metal would oxidize rapidly and even catch fire. Therefore, as the first precaution, the cooling water to all the rods in the reactor was decreased to a minimum by gradually throttling the flow of water through the valves leading to the main header. In this manner the flooding of the basement was decreased from 300 to 60 gpm. This was followed later with shutting off the cooling water to the rods which were not ruptured after installing special headers as shown in Fig. 3. Here, needle valves were used to control the flow at the top and bottom of each ruptured rod. After this installation was completed the leak to the basement was decreased to 14 gpm.

Fig. 3 Two different examples of ruptured rods which were involved in the accident

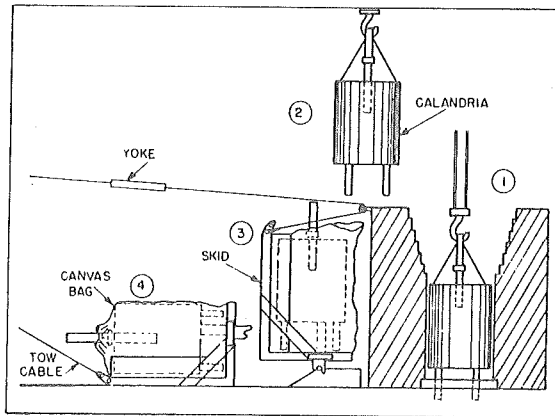
Fig. 4 Method of handling contaminated calandria tank, illustrating its removal to the disposal area

Radiation Measurements. Radiation measurements on this tank indicated 20 roentgens per hr in contact with the top tube sheet, 100 roentgens per hr in contact

with the side of the tank, and 300 roentgens per hr in contact with the bottom tube sheet.

In Fig. 4 a lifting jig was first lowered down on top of the calandria. This jig had dogs hanging below, designed in such a way that when the dogs entered the holes through the calandria tube sheet, they slipped outward hooking onto the underside of the sheet when a lifting strain was applied to the jig. The overhead crane hook was lowered and engaged by remote control to the hook on the lifting jig. The calandria was then raised out of the hole and, with the use of long ropes as guides, it was moved across the pile by the crane and lowered into a canvas bag which was attached to a skid turned up on one end against the side of the reactor.

The skid was then lowered into a horizontal position on the floor of the reactor building by slackening off on a yoke which was attached from the outer face of the skid to the inner face of the reactor and thence out to a bulldozer which acted as a winch. After the skid was

in a horizontal position on the floor, the pin was withdrawn from the outer end of the skid by means of a long rope attached. This released the skid from the yoke.

The skid was then towed out of the reactor building, with all remaining ropes attached, with the use of a grader, through the plant proper to the disposal area about $1\frac{1}{2}$ miles away.
