# Compendium of Research, Development and Demonstration – Results from a Canadian Underground Research Laboratory

## Grant Su, Geoscience Technical Specialist

Technical Meeting on the Compendium of Results of Research, Development and Demonstration Activities Carried Out at Underground Research Facilities for Geological Disposal

September 11–15, 2017

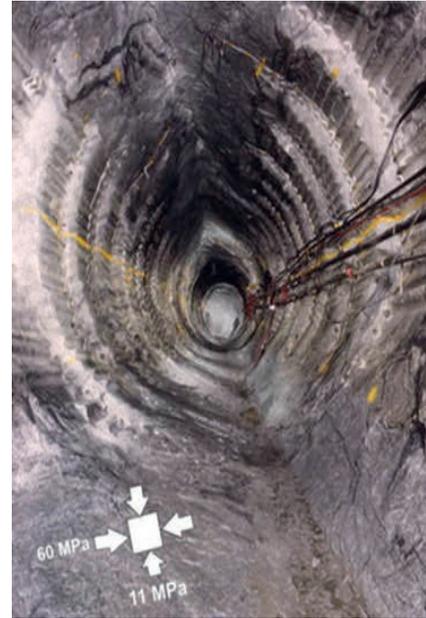
- study progressive failure and the development of excavation-induced damage around a 3.5-m diameter circular tunnel

- Context of experiments
  - conducted at the deepest level (420) of the URL, the experimental tunnel 415 was 46-m long, aligned subparallel to  $\sigma_2$  and was excavated mechanically; the *in situ* stress ratio in the plane perpendicular to the Mine-By tunnel exceeded 5 to 1
  - instrumentation included extensometers and convergence arrays to measure displacement, triaxial strain cells to measure strains, and thermistors to measure temperature; acoustic emission/microseismic (AE/MS) instrumentation to monitor the damaged zone development
  - over 500 data channels were monitored as the excavation progressed

- *in situ* crack initiation occurred at about 0.3 of the undisturbed lab strength  $\sigma_c$  and spalling initiated when the tangential stress around tunnel reached 0.5 to 0.6 of  $\sigma_c$
- once failure initiated near the tunnel face, progressive development of a v-shape around the tunnel occurred, which was similar to those observed in borehole breakouts
- the depth of intense fracturing at the notch tip was less than 30 cm
- fracturing beyond the stable tunnel perimeter was essentially non-existent at a lateral distance of 50 cm to either side of the north tip
