A Reactor Emergency

... with resulting improvements

By G. W. Hatfield

Atomic Energy of Canada Limited
Chalk River, Ontario, Canada

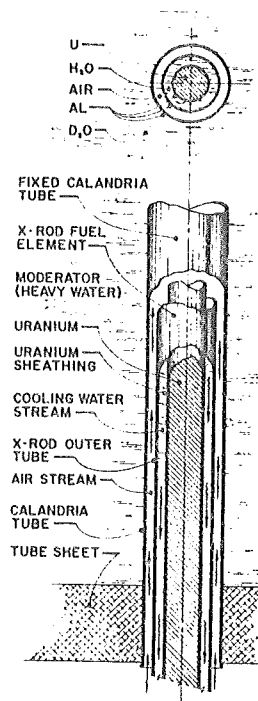
Fig. 2 Uranium-rod assembly inserted in reactor

Fig. 2 represents a uranium-rod assembly inserted in the reactor. It is to be noted that air passes up through the calandria tube around the water sheath of the uranium rod, which air removes a small portion of the heat generated. Fission products which escaped into this air stream were negligible at the time of the accident, being mostly of a short life.
